GODDARD SPACE FLIGHT CENTER

Failure Analysis Report

Project:	ESSP	Part Type:	Laser Diode Assembly
Subsystem:	CALYPSO	Manufacturer:	SDL
Date:	03 September 2003	Part Number:	
	SDL-32-00881		
Investigator:	F. Felt 286-9634	Serial Number:	D172
Requestor:	H. Leidecker 286-9180

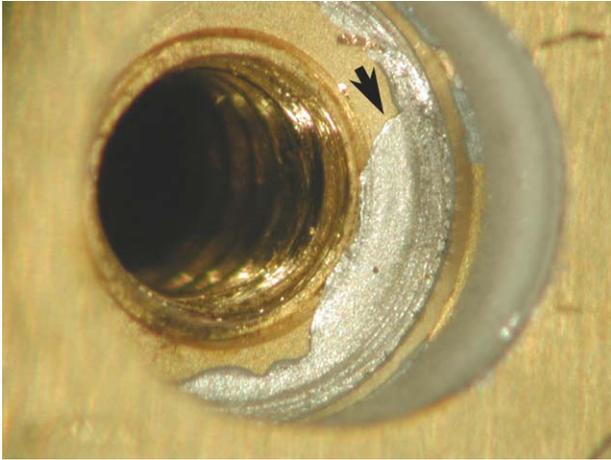
The laser diode assembly was externally inspected and photo-documented. High-power optical inspection of the wires suggested the formation of gold-indium intermetallic. The mounting block was also inspected, finding extruded indium in two bolt holes. This problem, believed to be due to over-torquing of the bolts, was identified as a cause of electrical shorting in a previous laser diode investigation.

Figure 5. Extruded indium was found in a bolt hole on the mounting block. This anomaly, apparently caused by over-torquing of soft indium, can cause an electrical short.

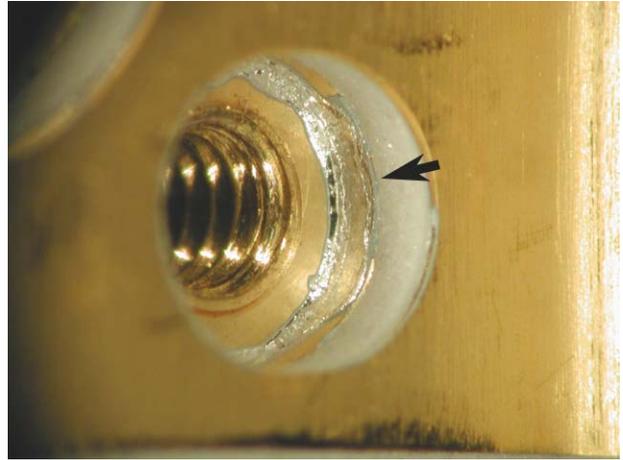
Figure 6. A second bolt hole with extruded indium is seen above.

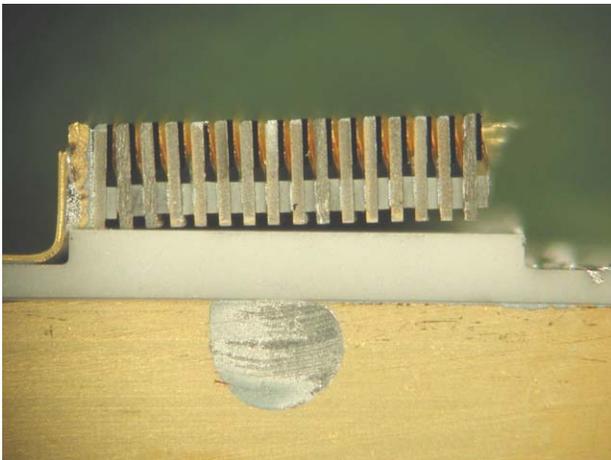
The cathode strap and cathode block were removed. Optical inspection showed that the entire assembly of sixteen (16) bars had lifted from the BeO substrate during removal of the cathode bookend.

Figure 7. When the cathode bookend was removed from the assembly, all the laser bars 'floated', unattached from the BeO substrate.

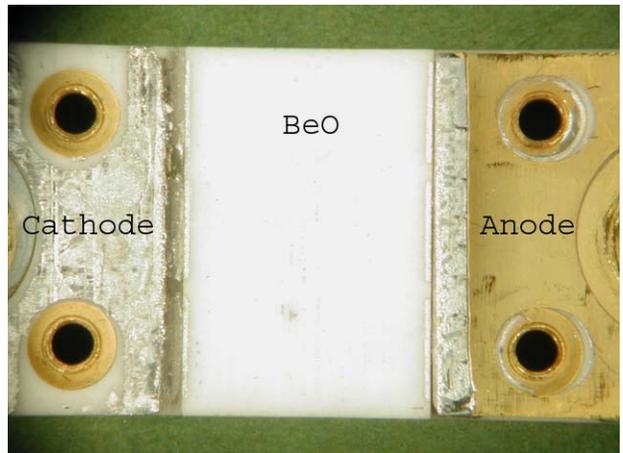
Optical inspection of the BeO heat sink with the laser bar units removed, found no evidence of indium, leading to the conclusion that the laser bars had not been properly heat-sunk. A single stripe of indium (each consisting of three segments) was found under the cathode, and anode blocks.

Figure 8. A top-down view of the BeO substrate after removal of all the bars shows no indium solder, except for three in-line segments at the cathode and anode.

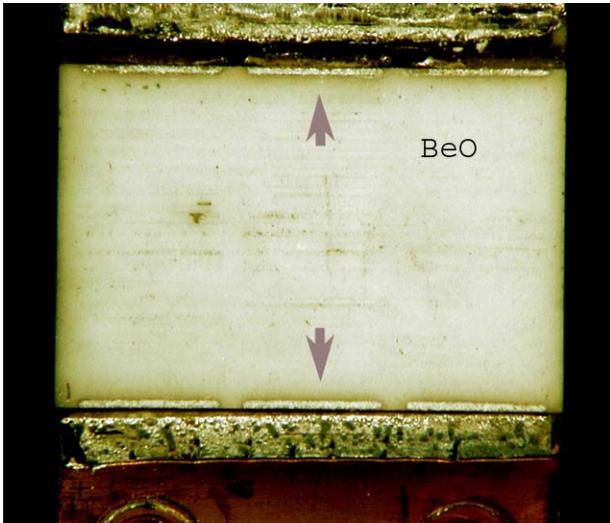
Figure 9. An enhanced view of the BeO substrate shows some striations from the bars. No evaporated indium was found, except for three segments indicated by arrows on both sides of the array.

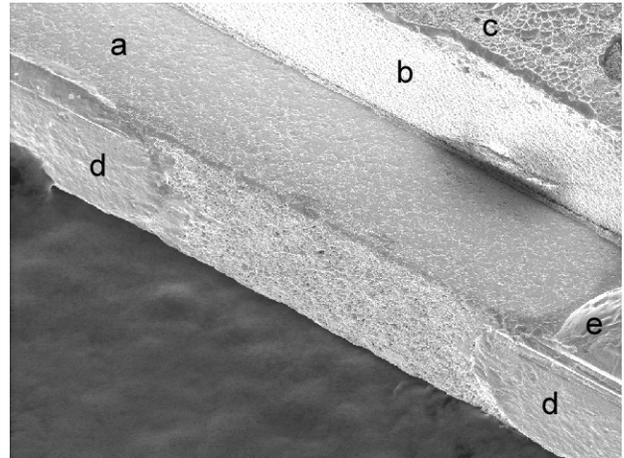
Figure 10. This view of the heat-sink side of Bar 13 shows the submount (a), the alumina spacer (b), and opposing ends of indium patches (d). A melted droplet of indium (e) is seen at lower right.

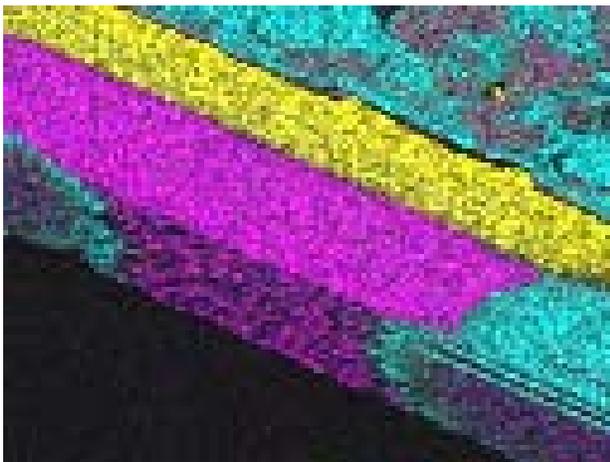
Figure 11. A matching EDS map of the image in Figure 10 shows indium (light blue), oxygen in the alumina (yellow) and gold film (purple) on the W-Cu submount.

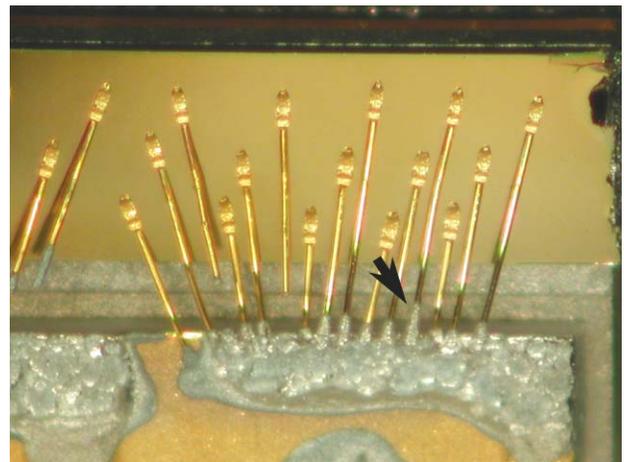
The laser diodes were inspected. Most wires exhibited gold-indium intermetallic formation. Many of these wires broke when the laser diode units were separated, because the massive intermetallic formation had effectively soldered the wires to the underside of an adjacent bar. On some laser diode units, most of the wires were broken and heavily encrusted with intermetallic. SEM inspection of several of these broken wires showed that the intermetallic growth had reduced the gold wire diameter by approximately one-third.

Figure 12. Low-power optical inspection of Bar 1 immediately found multiple gold wires affected by gold-indium intermetallic, one of which is indicated by the arrow.

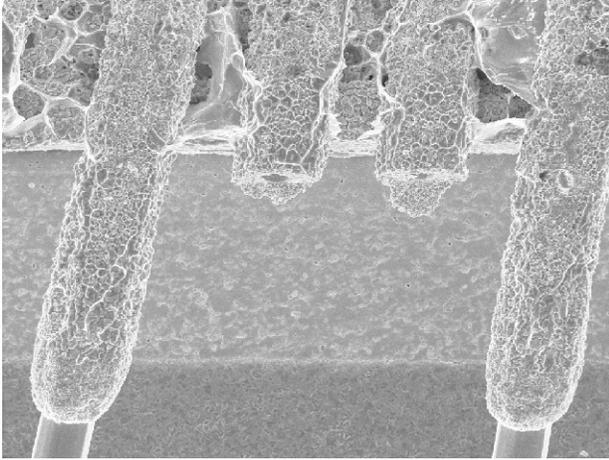
Figure 13. A view of four indium-affected gold wires on Bar 13. The two wires at center are broken because the wire was attached by intermetallic to the submount of the adjacent bar, and broke when the bars were separated.

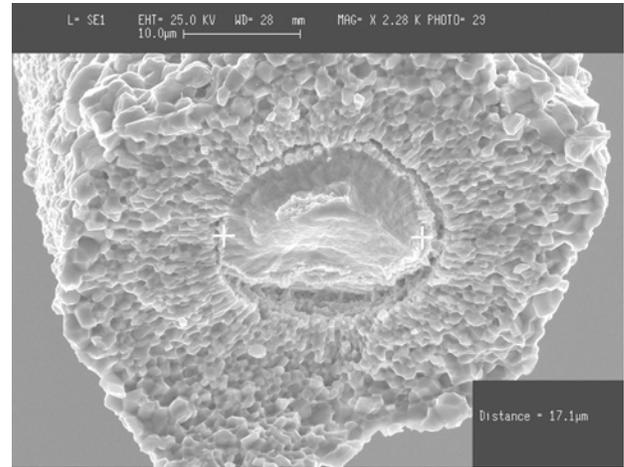
Figure 14. An end-on view of a broken wire from Bar 13 shows a gold wire at center measuring 17 μm .

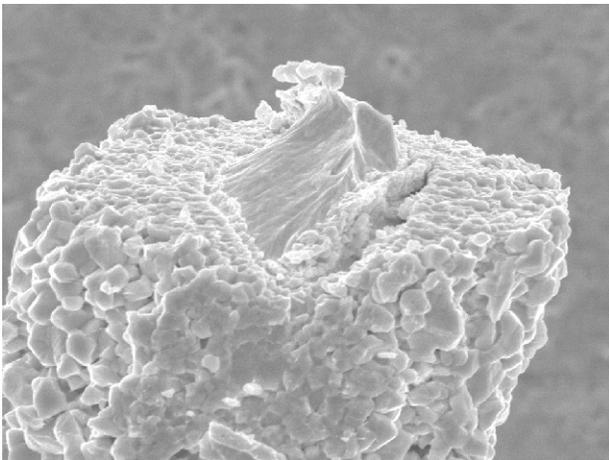
Figure 15. A side view of another broken wire shows evidence of tensile stress, presumably caused during disassembly because intermetallic had attached the wire to the adjacent submount.

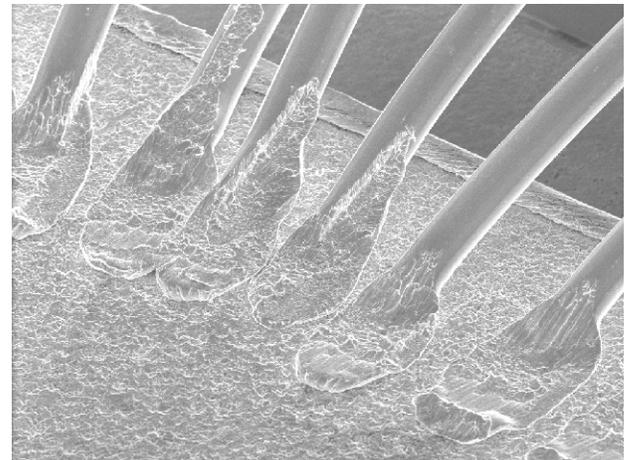
The wedge bonds on the gold wires at the spacer were inspected. Tool marks were found which had flattened wedge bonds and gouged wires. The close spacing of the wires and the repeating appearance of the marks strongly suggested the bonding tool dimensions exceeded the clearance between wires.

Figure 16. This image of some of the gold wedge bonds not affected by intermetallic shows evidence of damage by the bonding tool.

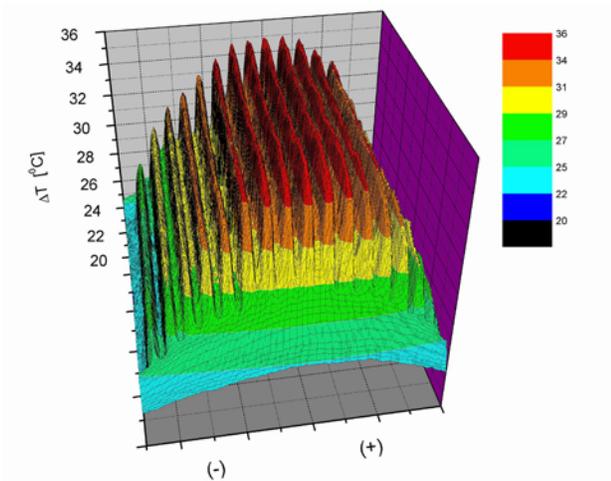
Figure 35. A 3-D infrared view of the D172 laser diode array, taken top-down. The parabolic distribution of temperatures across the array with higher temperatures at the center, is evidence that the laser diode units were not properly heat-sunk. When disassembled, no evidence of indium stripes was found on the BeO substrate under the laser diode submounts. (See Figures 8 and 9.)

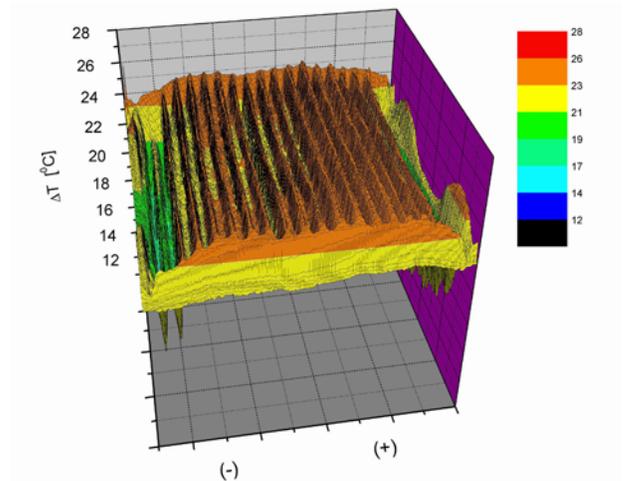
Figure 36. Compare to the Figure at left. The 3-D infrared view of the D243 laser diode above shows a much flatter temperature distribution across the array, presumably because the laser diode submounts were properly connected by indium to the BeO substrate.
