Appendix III

Photo Micrographs

Listing of Photographs

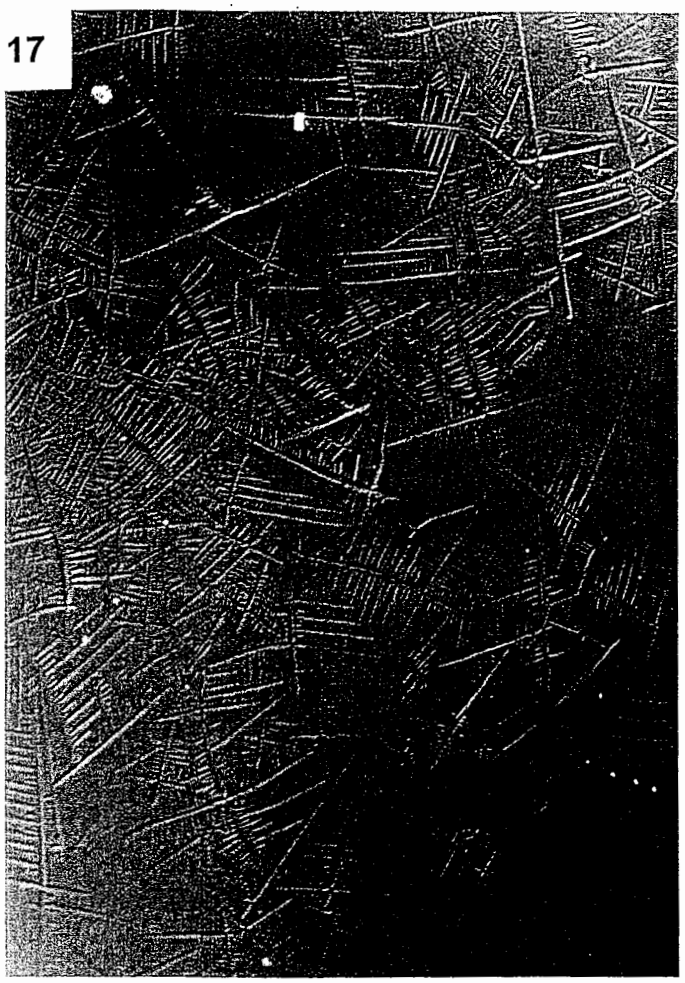
17

15) -17) Surface of L-13.

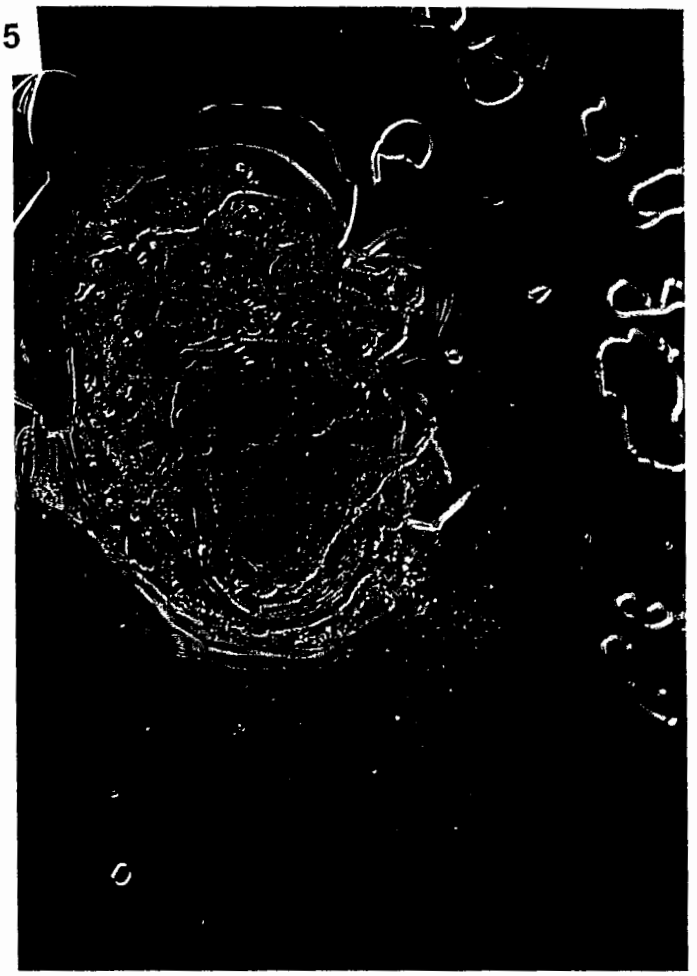
5

5) After photo showing damage of L-10. 40J/cm^2 .
