GODDARD SPACE FLIGHT CENTER

Failure Analysis Report

Project:	ESSP	Part Type:	Laser Diode Assembly
Subsystem:	CALYPSO	Manufacturer:	SDL
Date:	03 September 2003	Part Number:	
	SDL-32-00881		
Investigator:	F. Felt 286-9634	Serial Number:	D172
Requestor:	H. Leidecker 286-9180

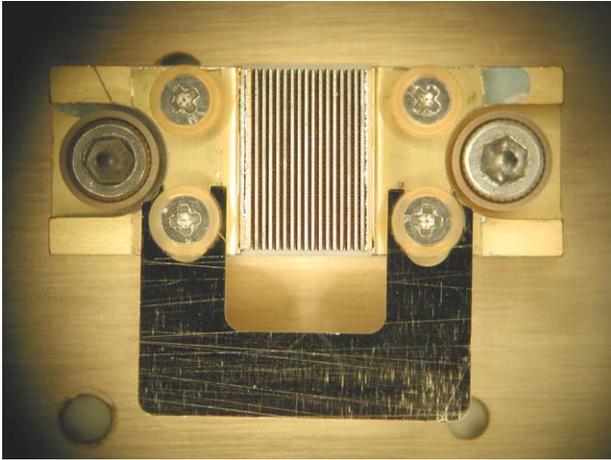
Figure 1. An overall top-down view of the D172 laser diode array with mounting bar, lugs, and safety shunt.

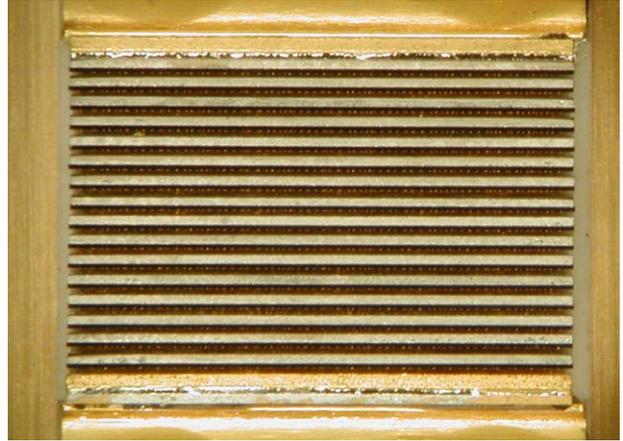
Figure 2. A close-up view of the sixteen (16) laser diode bars of the assembly.

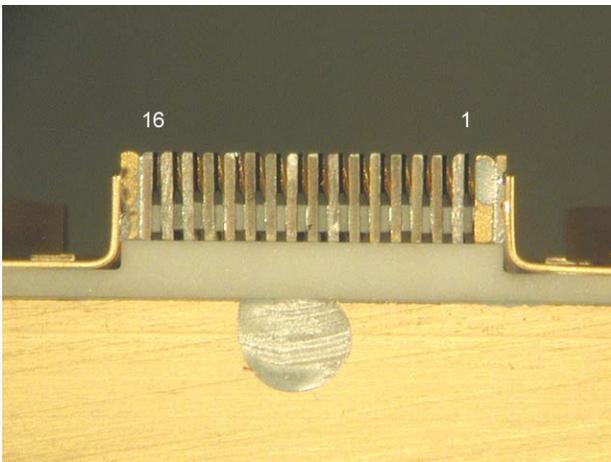
Figure 3. This image shows a side view of the D172 laser diode array. For the purposes of this analysis, the bars are numbered 1 through 16, as seen above.

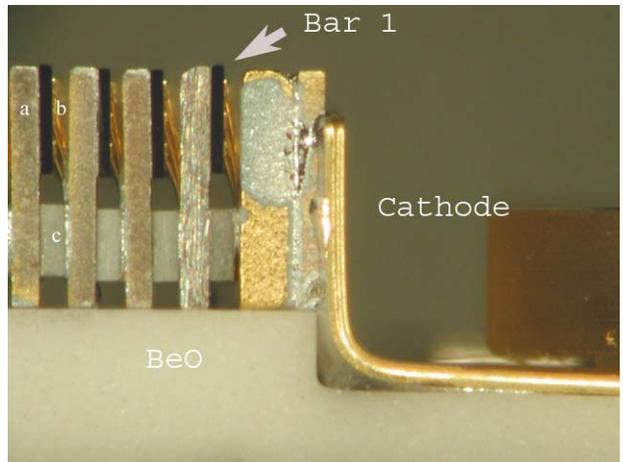
Figure 4. A detail side view of the cathode-end of the array showing the strap, bookend, BeO substrate, and four laser bars and submounts, beginning with Bar 1. The lettering identifies the submount (a), wires (b), and alumina spacer (c).

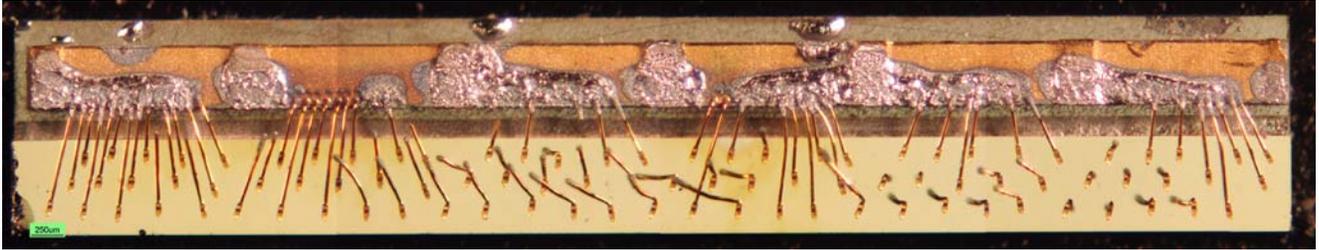
Figure 17. Bar 1

Composite images of laser bars were assembled using optical and SEM photographs. These images are found in Figures 17 through 34.

Figure 12. Low-power optical inspection of Bar 1 immediately found multiple gold wires affected by gold-indium intermetallic, one of which is indicated by the arrow.

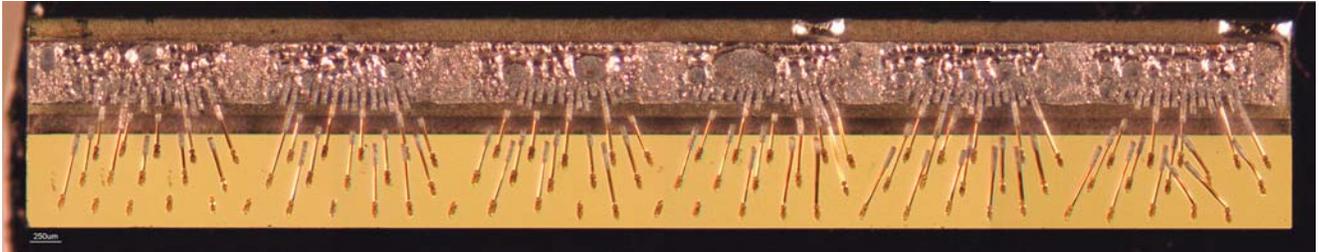
Figure 29. Bar 13.

Figure 13. A view of four indium-affected gold wires on Bar 13. The two wires at center are broken because the wire was attached by intermetallic to the submount of the adjacent bar, and broke when the bars were separated.
